Timber Repair saves College Gymnasium from the Wrecking Ball

Paul C. Gilham, P.E., S.E. MASCE

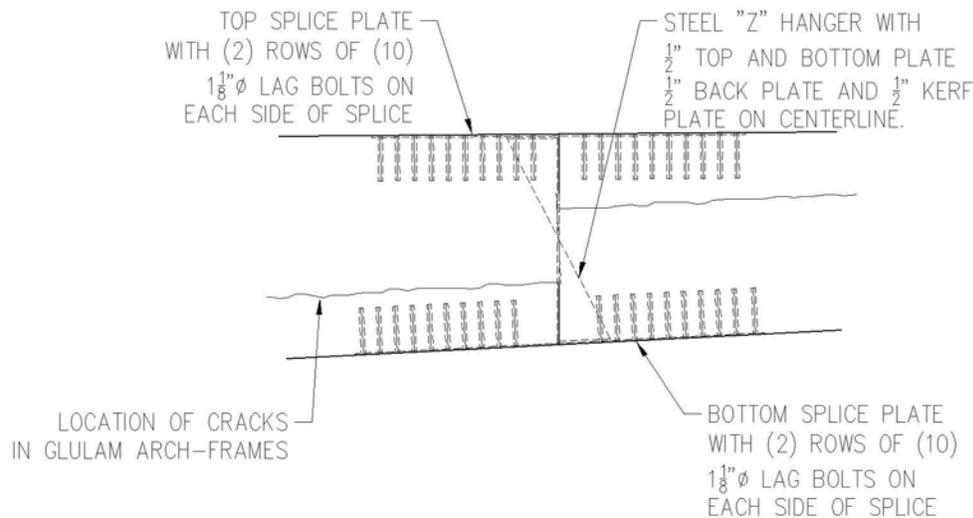
Figure 2. Moment Splice Layout.

The building was completed in 1969 but cracks were noticed at the moment splice shortly after the building was opened. A series of inspections were performed and it was determined that the cracks were not structurally significant as long as they didn't propagate. Each of the 18 arches had developed the splits in the same location which confirmed that there was an inherent issue with the design. The cause of the splits was identified by Robert Kaseguma of Unadilla Laminators in 1975. These arch-frames utilized a hidden moment connection consisting of top and bottom plates lagged into the members and a "Z" hanger that acted like a hinge connector. The top and bottom plates transferred the axial loads associated with the bending moments and the "Z" hanger transferred the shear loads from the center beam to the arch section. (See Figure 2) The downfall of this connection was that it did not allow the wood to shrink and swell with changes in the moisture content. To understand this, consider the center beam portion. It is supported on its base by the bottom plate of the "Z" hanger. When the wood shrinks, the member will shrink toward this bottom plate. However, the lag bolts in the top splice plate and

the stiffness of this top plate prevent this movement from occurring inducing tension perpendicular-to-grain stresses in the member. These perpendicular-to-grain stresses exceeded the strength of the wood and the split developed. The arches are approximately 56 inches deep at this point so even a small change in moisture content will result in a significant amount of shrinkage.

methods addressed the existing splits but did not remove the cause of the splits, i.e. the moment splice plates and the “Z” hanger. As long as these splice plates and “Z” hanger were intact, the arch member would experience tension perpendicular to grain stresses. It was determined that the previous repair attempts were able to close the splits but the internal stresses found the next weak link and the splits re-appeared.

The repair scheme needed to address these perpendicular-to-grain stresses while still transferring the shear forces from the center beam to the arch member. To do this the “Z” hanger had to be cut in two while in place and a new shear connection had to be installed on the outside face of the member.

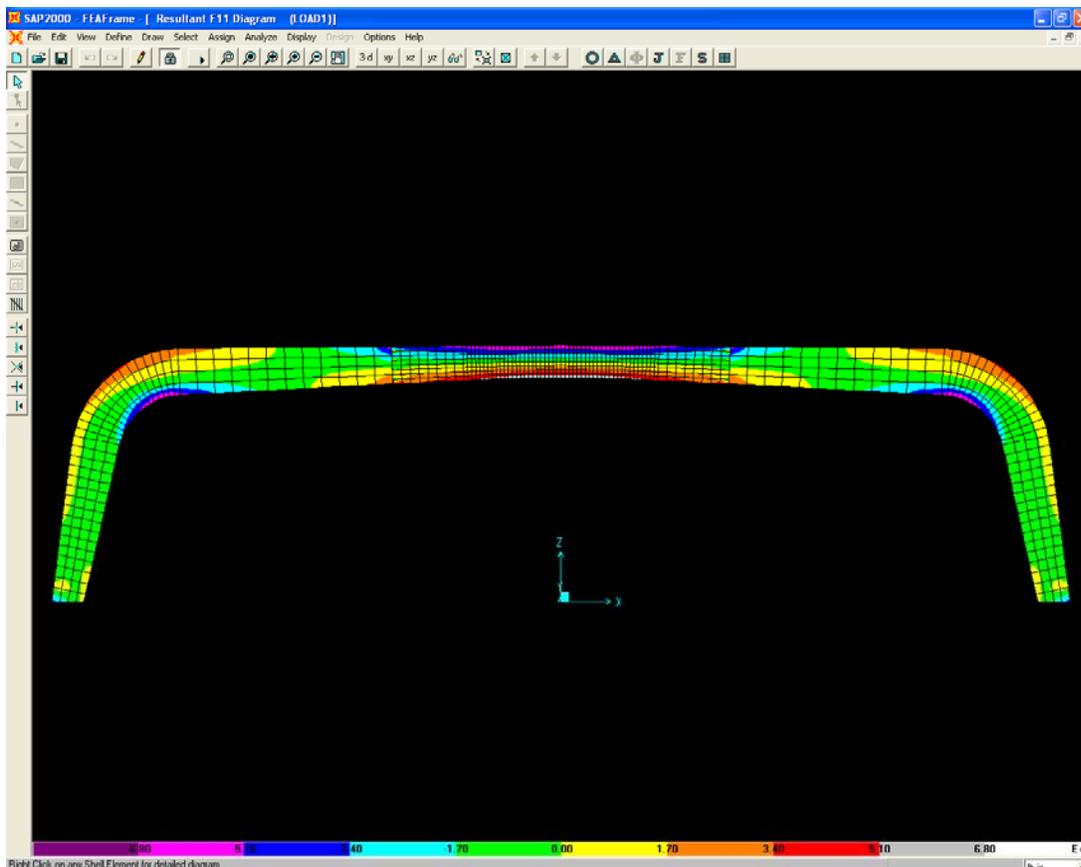
The center beam is a pitched and tapered curved beam. The top slope of the roof is 0.88 degrees. The tapered section and change of direction of these members at the crown causes an increase in the bending stress. The design method for determining the actual bending stresses for these types of members is specified in the AITC Timber Construction Manual (TCM). However, this procedure was developed for members with a minimum top slope of 2.5 degrees. This procedure does not include members with combined axial and bending stresses. Finally, the research used to develop these methods only considered members that were deeper at the crown than at the supports. To account for these deviations from the method specified in the TCM, the arch frame was analyzed using the finite element method (FEM). The bending stresses given in this analysis were compared to those derived from a straight frame analysis. The bending stress factor, K_{θ} , for this member was determined by dividing the bending stress found in the FEM analysis by the bending stress found in the frame analysis. K_{θ} was determined to be equal to 1.14 from this analysis. Using this value, the beam was found to be overstressed 125.4 percent in combined bending plus compression on the bottom or tension side of the beam. (See Figure 4)

The results of these analyses indicated that the arches were deficient in bending at the haunch and at midspan and that the top plate and lag bolts in the moment splice were insufficient to transfer the tension due to bending at the splice.

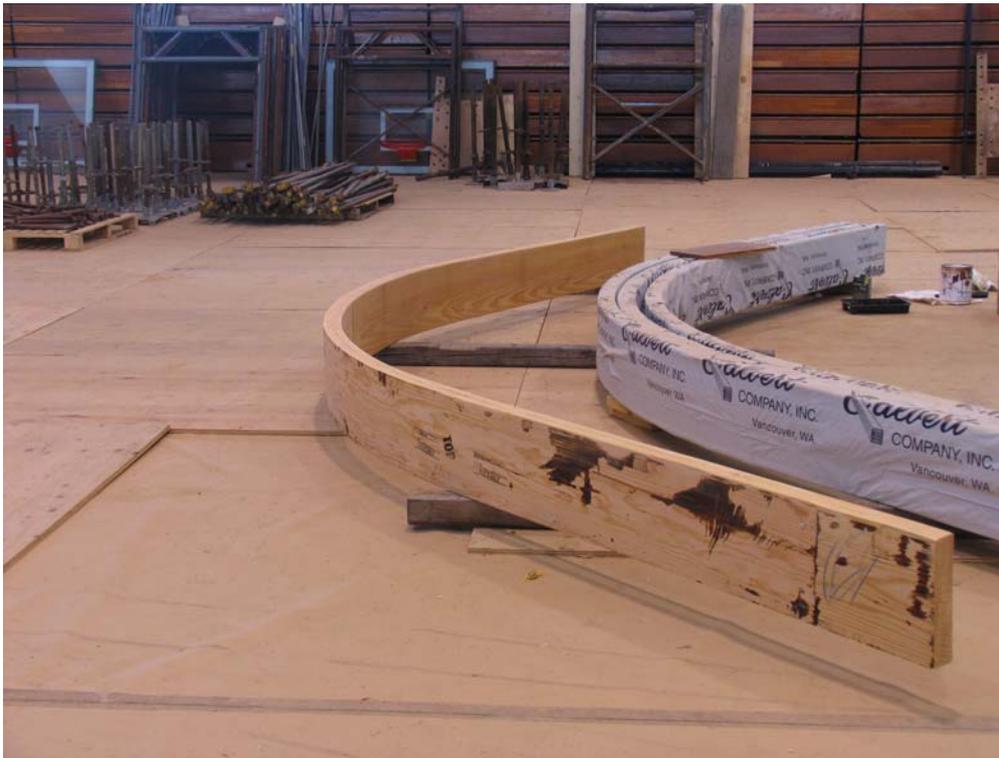
Figure 5. Glulam billets for reinforcing the arch haunch.

At the arch haunch, the members were overstressed by 8.5 percent in bending. The bending stress at the haunch results in compression on the inside face and tension at the outside face of the arch. Due to the curvature of the member, it is not practical to relieve the tensile forces due to bending with a post-tensioning system. Therefore the upgrade required adding four additional 5/8" laminations to the soffit of the arch. A profile of the arch curvature was prepared and sent to a laminator who made full-length billets. (See Figure 5) These billets were then drawn up tight to the arch with clamps and hydraulic jacks and attached with a structural adhesive and screws. (See Figure 6)

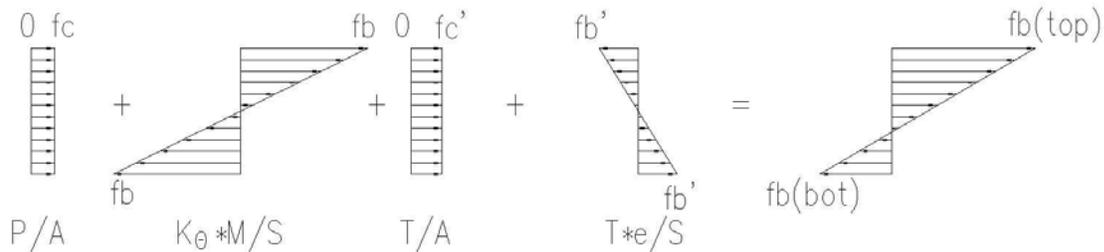
Figure 7. Summation of applied stresses and post-tensioning stresses

As mentioned previously, the center beam was overstressed 125.4 percent in combined bending and compression at midspan. A cable post-tensioning system was used to reduce the tensile stresses in this location. Two cables were installed on the beam soffit and post-tensioned to

12,000 lbs. each. The cables are located with an eccentricity from the beam centerline, and induce compression and negative bending into the member. The compression and bending stresses due to the post-tensioning force are summed with the bending and compression in the member due to applied loads to determine the net bending stress in the member. This bending stress must be less than the allowable bending stress on the tension side of the beam. Figure 7 shows the summation of these stresses graphically.

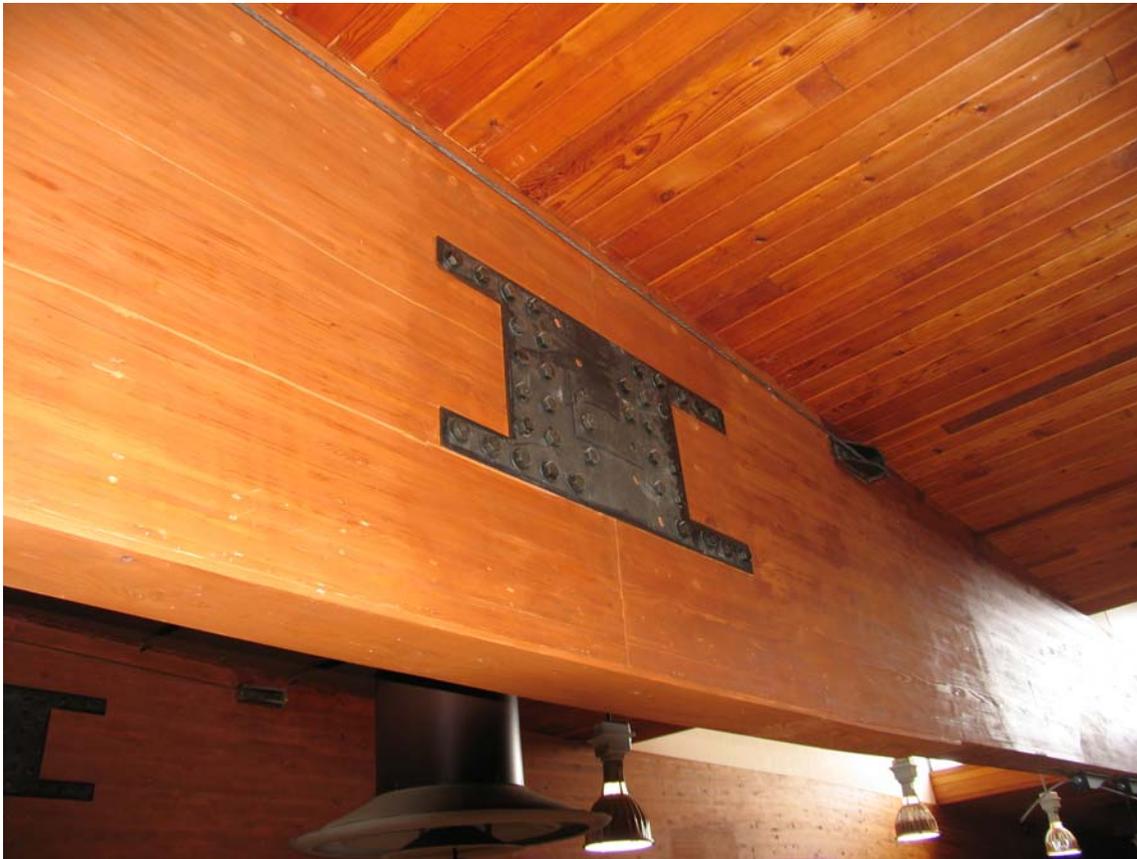
Figure 9. Steel side plates used to transfer reaction from center beam to arch section. The paste type of epoxy used to seal the member at the original split does not receive the stain and can be seen as a light line at the bottom of the plate. The post tensioning cable for the top plate is seen next to the timber decking.

The repair procedure called for splitting the “Z” hanger at the middepth of the splice. This eliminated the ability of the splice to transfer the shear due to the reaction of the center beam to the arches. Steel side plates were designed to replace the “Z” hanger. These plates used three rows of four 1” ϕ machine bolts loaded perpendicular to grain to transfer the 43,432 lb. reaction from the center beam to the arch. These bolt groups were centered 8” on either side of the splice location. The rotation of the side plate caused by the eccentricity of the bolt groups is resisted by one row of five 1” ϕ bolts at the top and bottom of the plate. These bolts are loaded parallel to grain. The holes for these “rotation” bolts are slotted vertically to eliminate splitting of the member due to shrinkage between these outer rows of bolts and to limit the resistance of these bolts to parallel to grain loads only. The bending moment at the connection is resisted by the existing top and bottom plates and lag bolts. (See Figure 9)

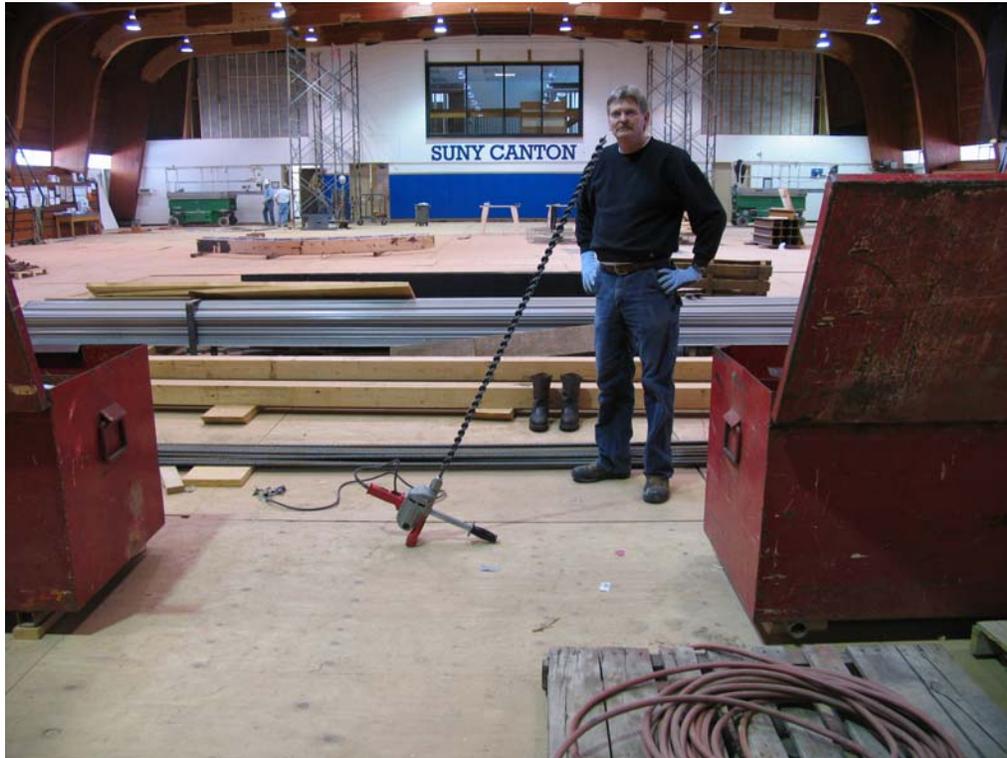
Figure 10. WWSI jobsite superintendent, Ray Kennedy with 54 inch drill bit used to drill for epoxy dowels.

Finally the split members were repaired by installing epoxy shear dowels through the depth of the member. These dowels consist of reinforcing bars inserted into vertically drilled holes which are subsequently pumped full of epoxy. These dowels serve to restore the shear capacity of the member and reinforce the member against future splitting. Two 54” long shear dowels were

installed immediately adjacent to the splice location on each side and two rows of dowels were installed along the length of the member 9" on center for the length of the split plus six inches. The sides of the member are sealed with a paste type epoxy and the dowels are then pumped full of a low viscosity epoxy. An injection port is drilled into the side of each vertical hole near the bottom of the member and an exhaust port is drilled into the top of the member. The epoxy is pumped into the injection port until it fills the hole and exits through the exhaust port. The epoxy fills all of the voids in the member as it rises in the vertical holes. Figure 10 shows one of the drill bits used to drill a 54" hole in the arch member and Figure 11 shows two workmen pumping epoxy into the arch.

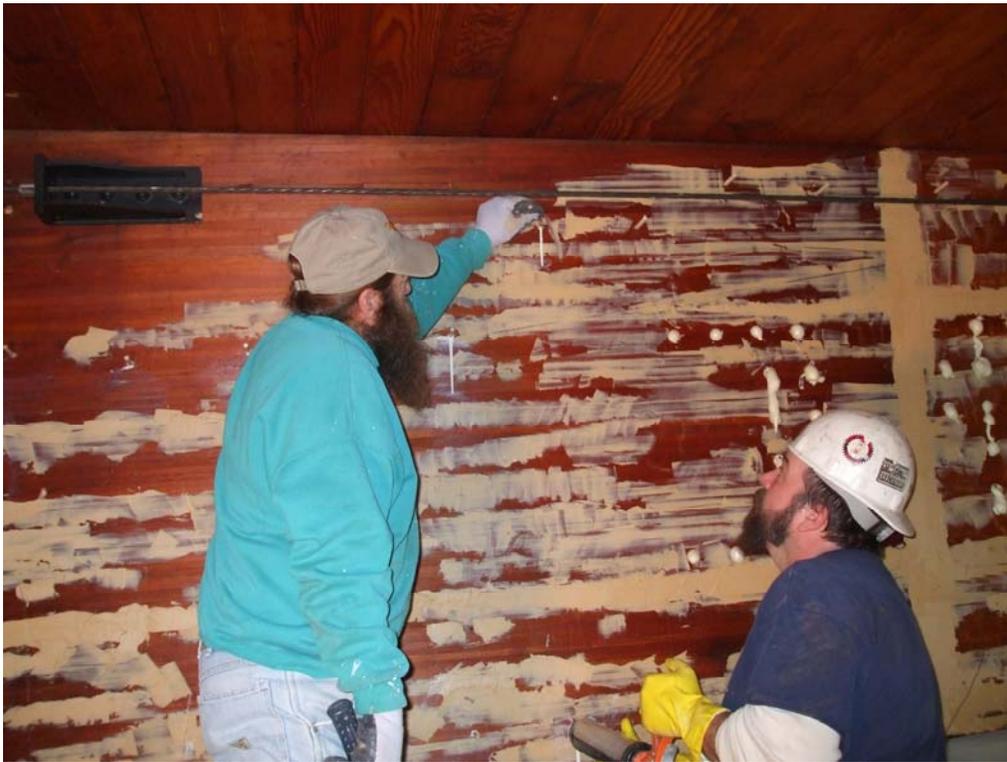
Figure 11. Workmen pump epoxy into arch member. The member is completely sealed to prevent the epoxy from leaking while allowing the epoxy to fill all of the voids in the member.

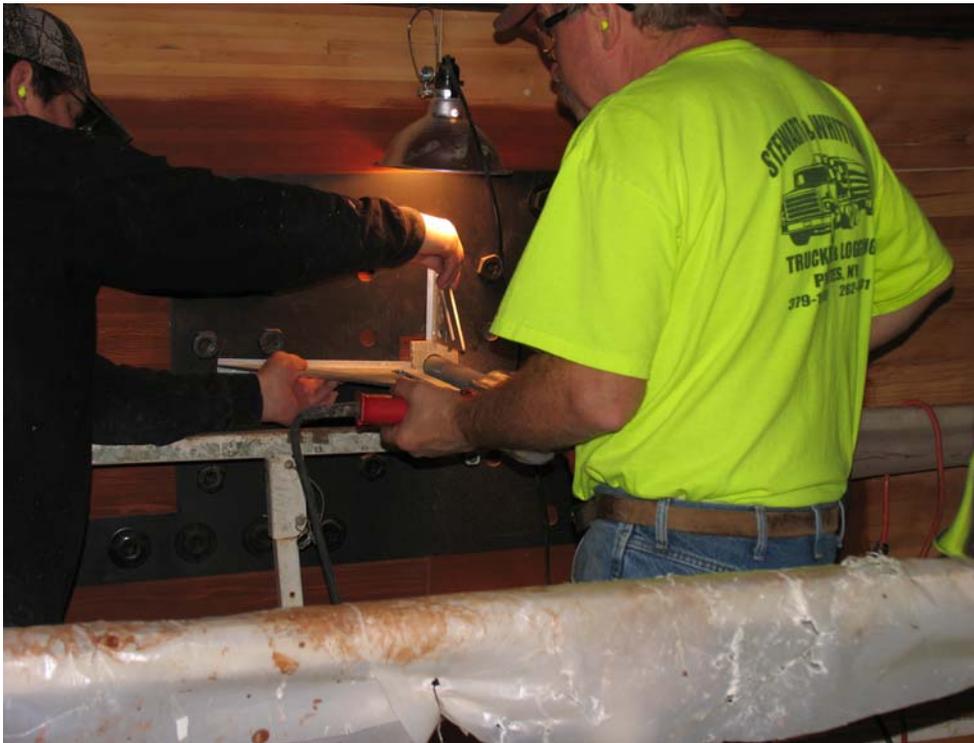
Figure 12. Cutting the “Z” hanger in half with rebar cutting bit. The workman on the left is using two framing squares to align the drill bit. It took just over an hour to core through the $\frac{1}{2}$ ” x 10” back plate of the “Z” hanger.

Once the side plates are installed, the “Z” hanger is cut in half using a rebar cutting bit. This procedure removes the restraint in the member that was causing the splitting. $1\frac{1}{2}$ ” ϕ rebar cutting bits were used to core out a $1\frac{1}{2}$ ” hole at the mid-depth of the member which effectively separated the top of the Z hanger from the bottom. (See Figures 12 and 13) Additional holes were drilled through the kerf plates and the kerf plates were completely separated using a reciprocating saw.

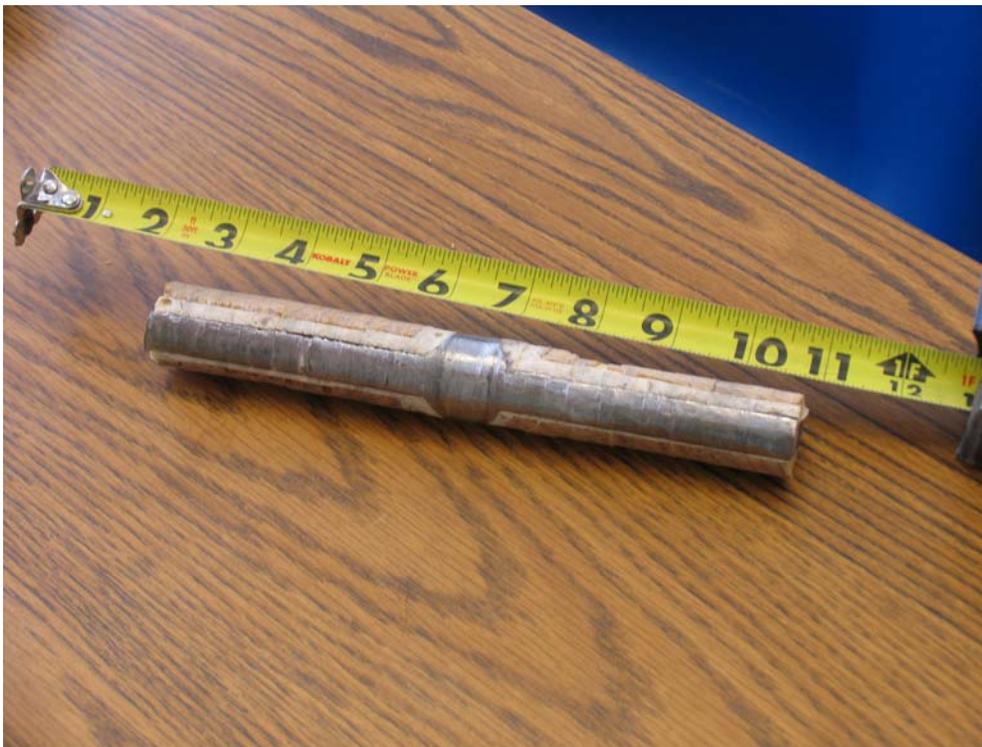
Figure 13. Core removed from arch at “Z” hanger. The center kerf plate is at the center of the member.

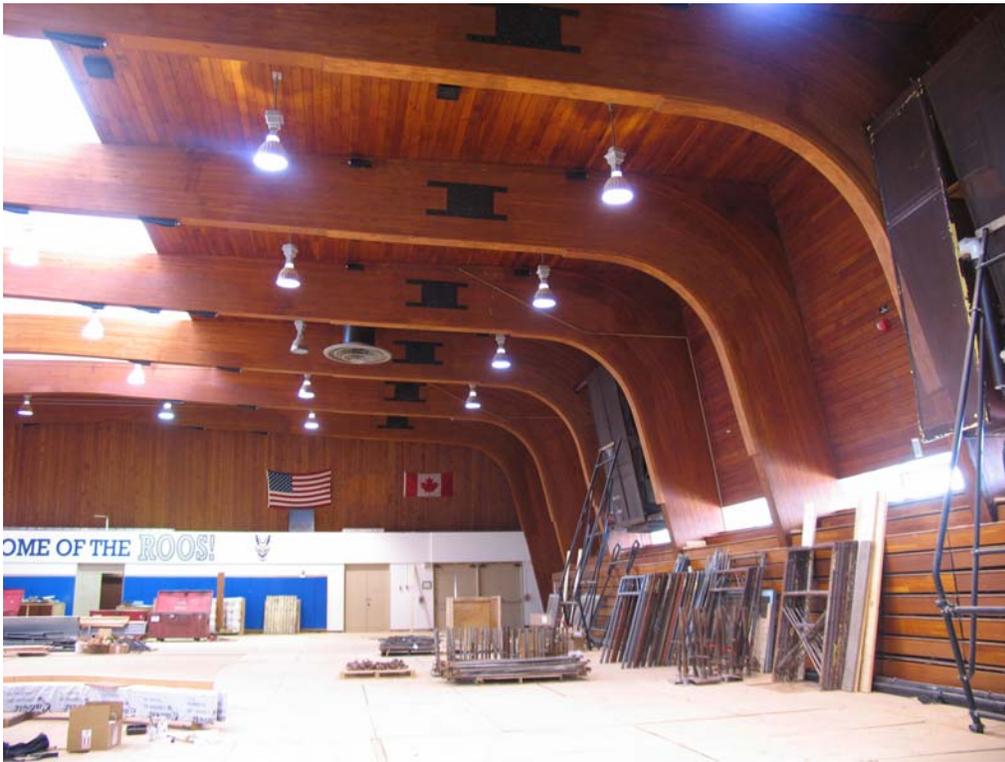
Figure 14. Frames with structural repairs complete, sanded and stained.

Once the structural repairs were completed, the arches were sanded smooth and stained. The repair procedure required four months to repair 13 arch-frames. This repair procedure saved the college more than \$1 million, when compared to the price of demolition. This repair scheme also preserved building space desperately needed by the college.
