Timber Repair saves College Gymnasium from the Wrecking Ball

Paul C. Gilham, P.E., S.E. MASCE

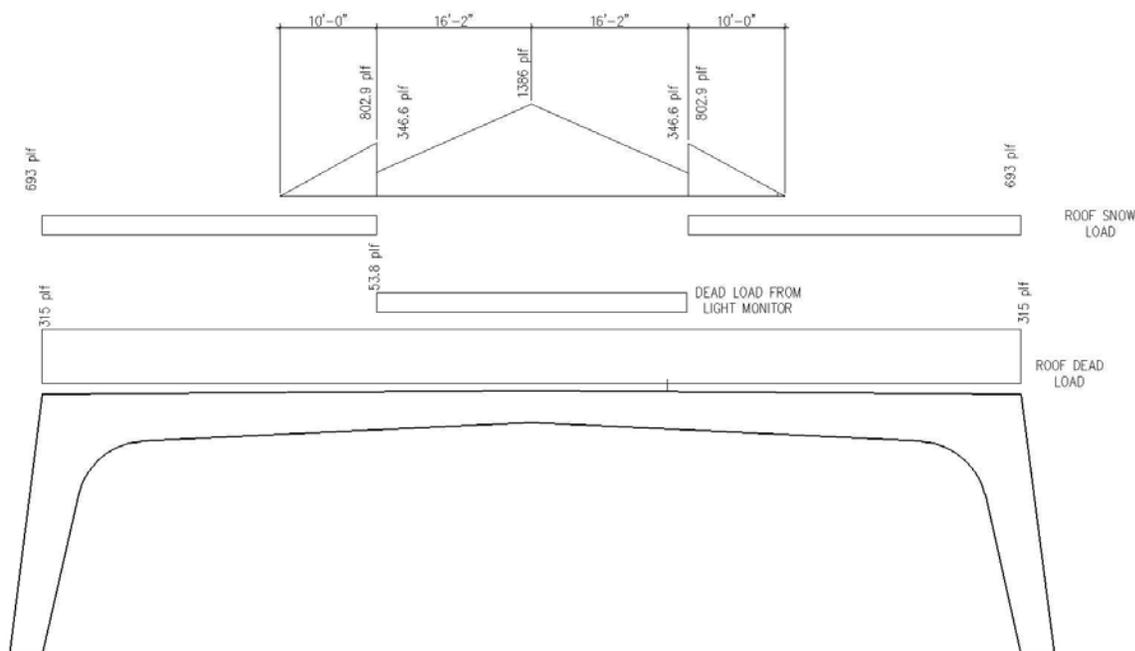
Figure 3. Loading diagram at arch.

Additionally, the college requested that the repair scheme upgrade the capacity of the arches to meet the 2007 Building Code of New York State (BCNYS) snow load requirements. Prior to the 2007 BCNYS, the design snow load for Canton was 40 psf. The 2007 BCNYS specifies a ground snow load of 60 psf. Using an importance factor, I_s , of 1.1, an Exposure factor, C_e , and a thermal factor, C_t , equal to 1.0, results in a roof snow load of 46.2 psf. Additionally, the effects of drifting snow adjacent to the light monitors and a buildup of snow in the well of the light monitor was to be considered. A uniform dead load 21 psf was used. This loading is shown in Figure 3.
